PHYSICAL NEEDS ASSESSMENT

**THE HOUSING AUTHORITY OF THE
COUNTY OF CHESTER**
30 WEST BARNARD STREET, SUITE 2
WEST CHESTER, PA 19382

K&A
ARCHITECTURAL SERVICES, LLC
K & A Architectural Services, LLC

SUBMITTED: MARCH 9, 2011
REVISED:

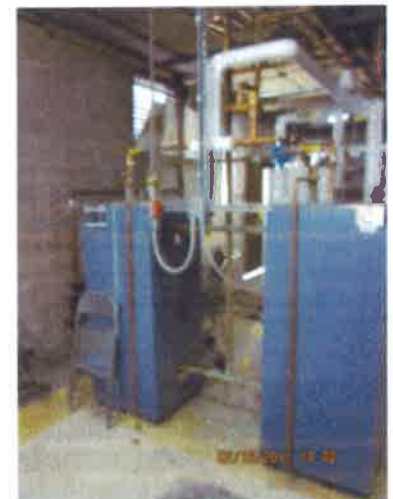
Boilers

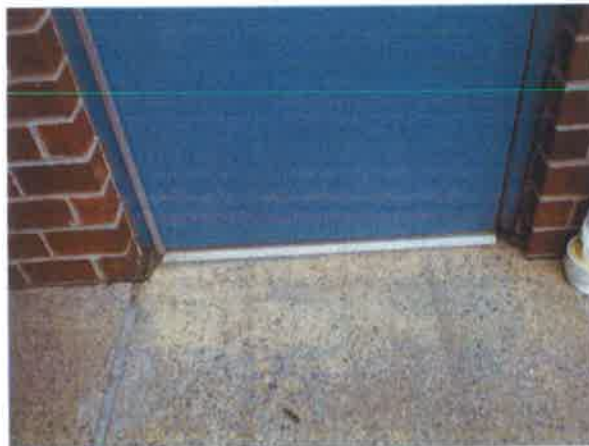
Rusting Exterior Doorframe

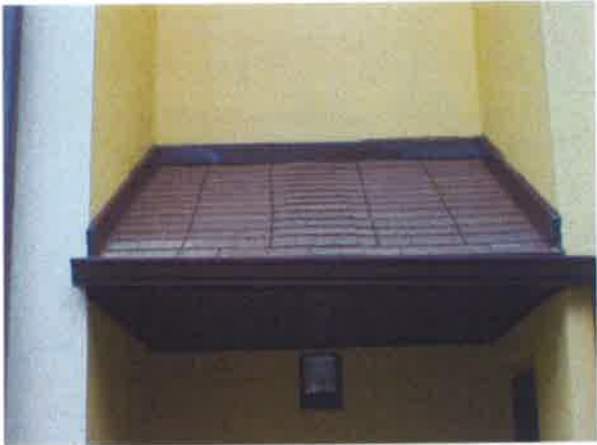
Rear Porch Roof

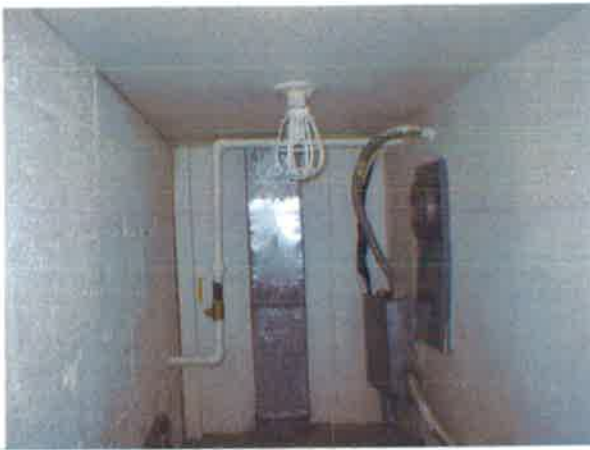
Beneath Stair Landing/Utility Closet
