PHYSICAL NEEDS ASSESSMENT

**THE HOUSING AUTHORITY OF THE
COUNTY OF CHESTER**
30 WEST BARNARD STREET, SUITE 2
WEST CHESTER, PA 19382

K&A
ARCHITECTURAL SERVICES, LLC
K & A Architectural Services, LLC

SUBMITTED: MARCH 9, 2011
REVISED:

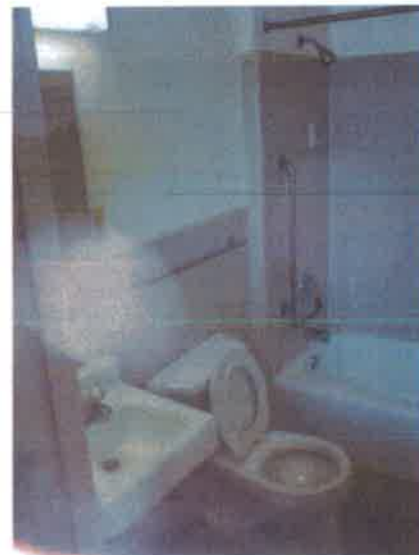
Apartment Bath

Dwellings: Bathroom has enameled cast iron tub, tile surround. Toilet accessories not inventoried, but are a continual maintenance issue. Expanded bathrooms at accessible units dark because of lighting layout. Provide ADA bathrooms.	3
Dwelling: Baseboard heat from central boiler. Air conditioning by tenant with window units. Smoke detectors in each bedroom.	
Mechanical plant: Central hydronic heating boilers are located in the basement of the OIC building, feeding the baseboard radiators of the 3 residential	1-Shut-off valves

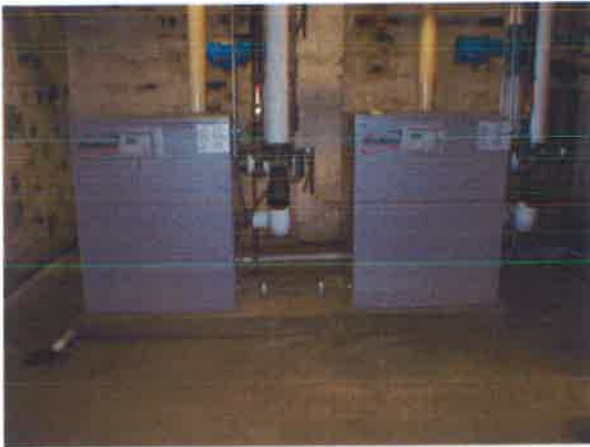
OIC Boilers

buildings via insulated underground piping. The new boilers & system appear to be in good condition. The boilers feed indirect water heaters for domestic hot water. Shut-off valves are recommended for replacement. Insulation on piping was missing. Mixed pipe material without dielectric fittings were observed	2-Insulation 3-Dielectric fittings
Water system: Indirect water heater fed by heating boilers. The system appeared satisfactory. Isolation valves and shut-off valves may need replacement.	2. Shut-off valves 2-isolation valves
Electrical service and distribution: One panel serves each group of four units.	
Emergency & life safety. Smoke and CO detectors. Manual fire alarm pull stations provided throughout the OIC building. No fire suppression system provided; not required in OIC building.	
Ventilation:	
Accessibility: Can be improved by updating designated handicap apartments to fully accessible units. Laundry room not accessible (clear area at door and door hardware) Signage not compliant (or lacking altogether)	1-accessible dwellings

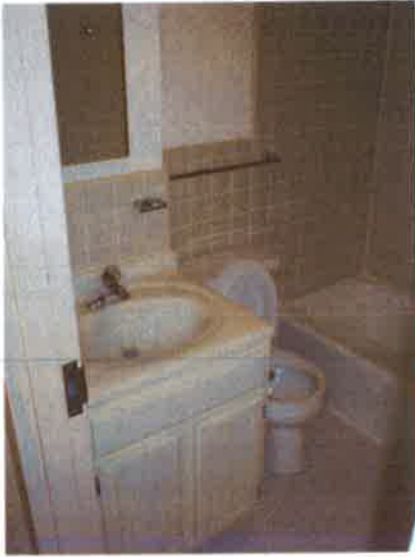
Apartment Bath

Dwellings: Floors typically carpet over unknown substrate; Kitchen floor sheet vinyl. Ceilings GWB. Walls GWB. Bathrooms sheet vinyl with tile wainscot. Interior doors swing; larger bedroom closets have bi-pass doors. Bathroom doors have pivot hinge with hospital latch. Lighting fixtures are new; closet lights bare bulb with basket protective. Units have wood stair with wood railings; landings VAT/VCT. Hookups provided for washer in Kitchen. Larger family units require more immediate repairs to walls, doors and floors.	3
Dwellings: Kitchen cabinets. Kitchen counters are plastic laminate. 24-inch gas range, single bowl sink, refrigerator, and range hood. Range splash guard provided. Replace cabinets & counters with HUD approved materials. Replace ranges. Provide ADA kitchen cabinetry.	1-20% 2-ranges
Dwellings: Bathroom has enameled cast iron tub, ceramic tile surround. Toilet accessories not inventoried, but are a continual maintenance issue. 4-BR units have a separate shower room and ½ bath instead of a full second bath. Provide ADA bathrooms.	1-10%

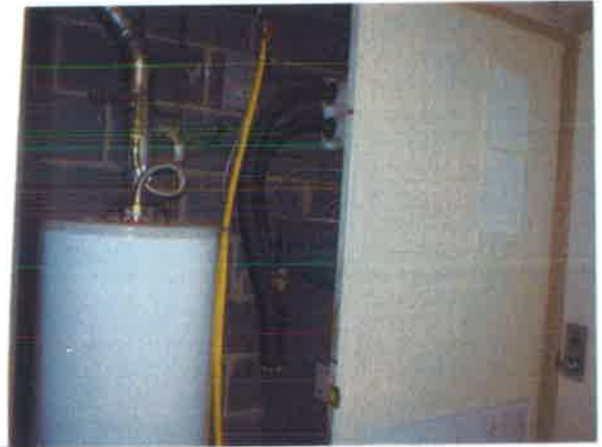
Apartment Mechanical Closet

Dwelling: Forced air heat. Air conditioning by tenant with window units. Smoke detectors in each bedroom.	
Mechanical plant: In each unit. New geothermal system. Central gas meter. Ductwork at floor penetrations is recommended to be repaired to prevent supply	1-Duct collar at floor

air leakage in the floor ceiling cavity	outlets
Water system: A single site main and meter serves the all units. Replace shut-off and isolation valves. The site does not have a sprinklers system.	2-Shut-off valves 2-Isolation valves
Electrical service and distribution: Central meter. Unit panel and abandoned meter socket located under first floor stair landing. Unit devices are worn and should be replaced. Recommend relocation dwelling unit panels to an easily accessible location.	1-50% devices 3. Relocate panel
Emergency & life safety. Smoke and CO detectors.	
Ventilation: Ventilation of utility room poor.	1
Accessibility: Can be improved by updating designated handicap apartments to fully accessible units.	1-accessible dwellings
